REPORT OF MARINE SURVEY

"XXXXXXXXXX"

2006 Viking Sport Cruiser SC57

**Barton P. Cerra
on
November 19, 2019**

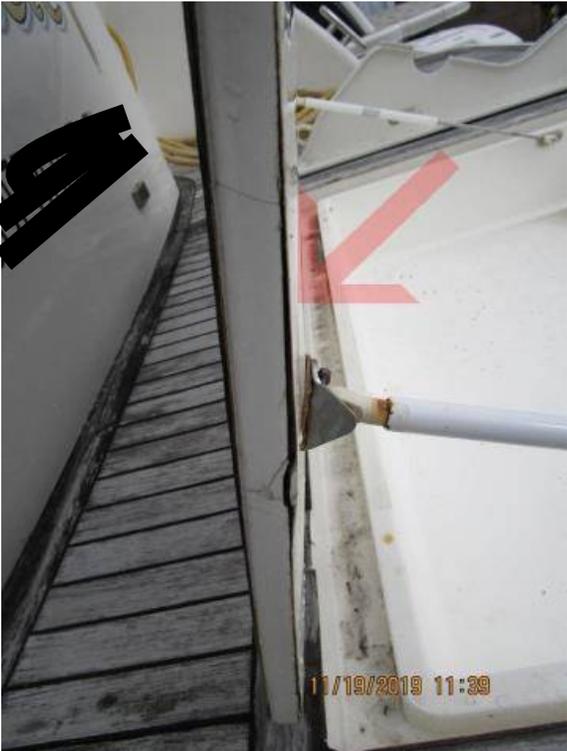
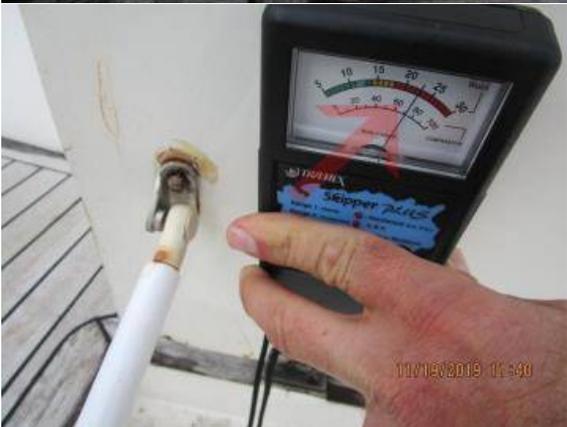
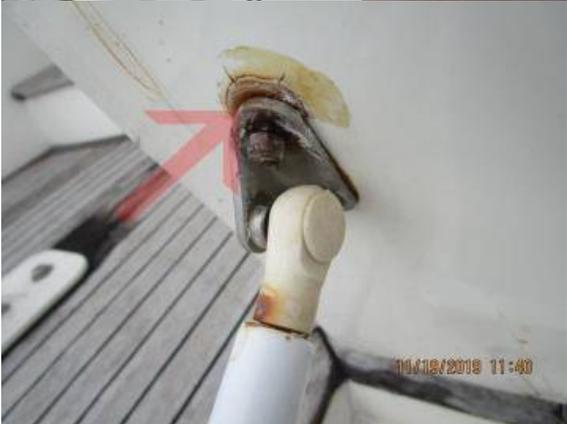
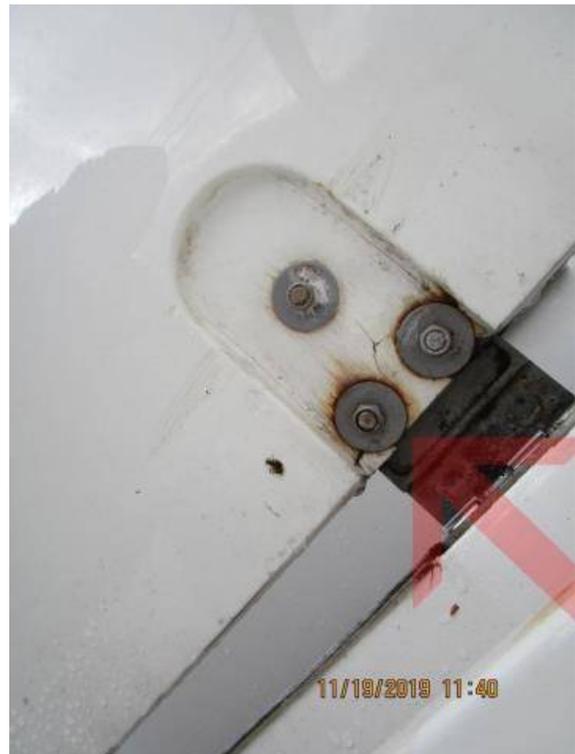
Transom storage:

Storage areas molded in at transom. Transom hatch shows signs of delamination and moisture readings are excessive. Struts are stripping out of core material and water is dripping from the hinge areas. Cracking was also sighted around the perimeter of the hatch.

| Findings: | Recommendations: |
|---|--|
| Transom hatch shows signs of delamination and moisture readings are excessive. Struts are stripping out of core material and water is dripping from the hinge areas. Cracking was also sighted around the perimeter of the hatch. | Have a qualified FRP technician further investigate, evaluate and repair as necessary. |

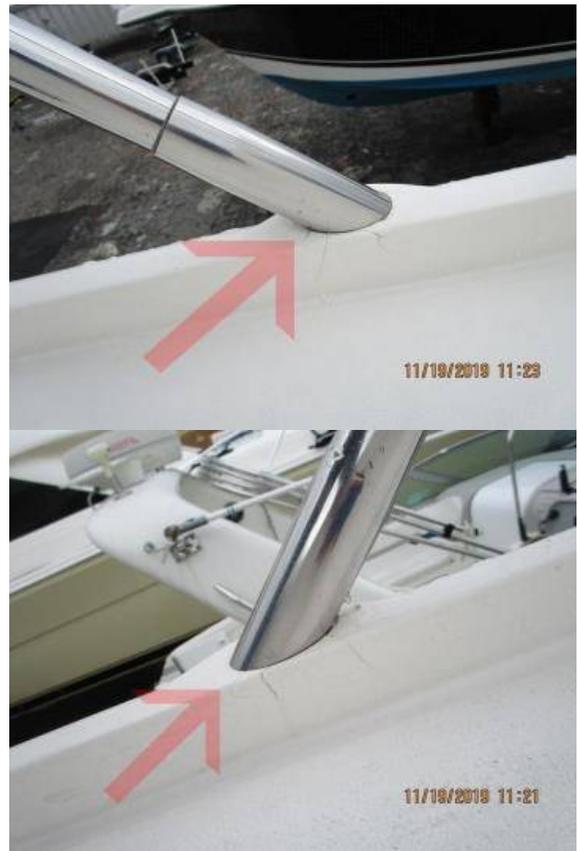
Stanchions/side rail(s): Stainless steel, well secured.
 Moderate stress cracking sighted at the base of the sixth stanchion going forward from aft on both the port and starboard side.

Recommendations: Have a qualified FRP technician further investigate stress cracks sighted at stanchion bases, evaluate and repair as necessary.

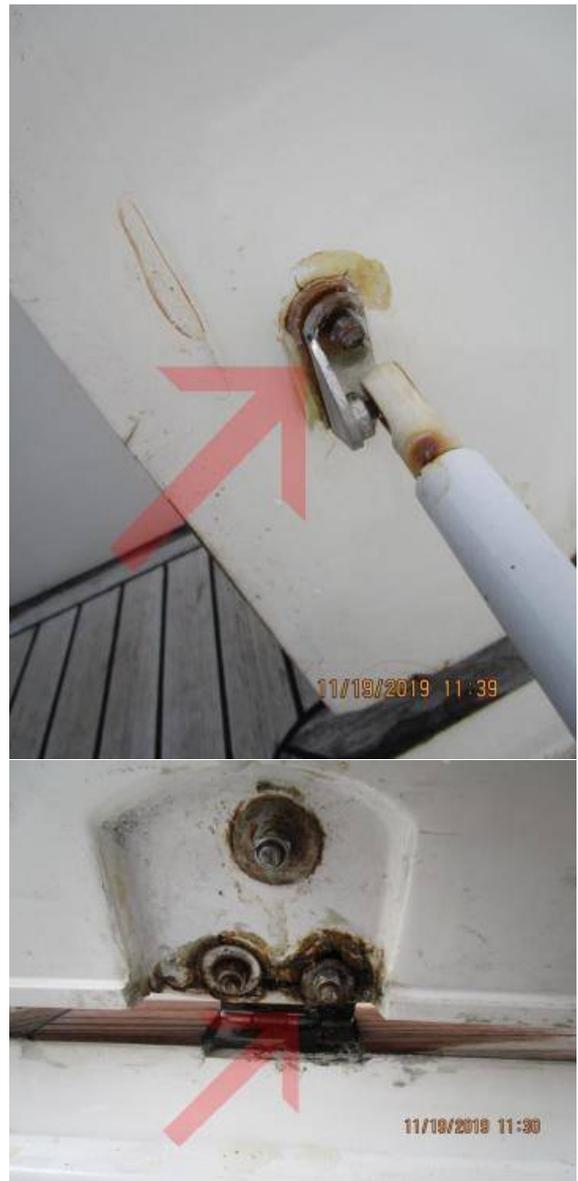
Moisture/Delamination: Cockpit hatches shows signs of delamination and moisture readings are excessive. Struts are stripping out of core material and water is dripping from the hinge areas. Cracking was also sighted around the perimeter of the hatch.

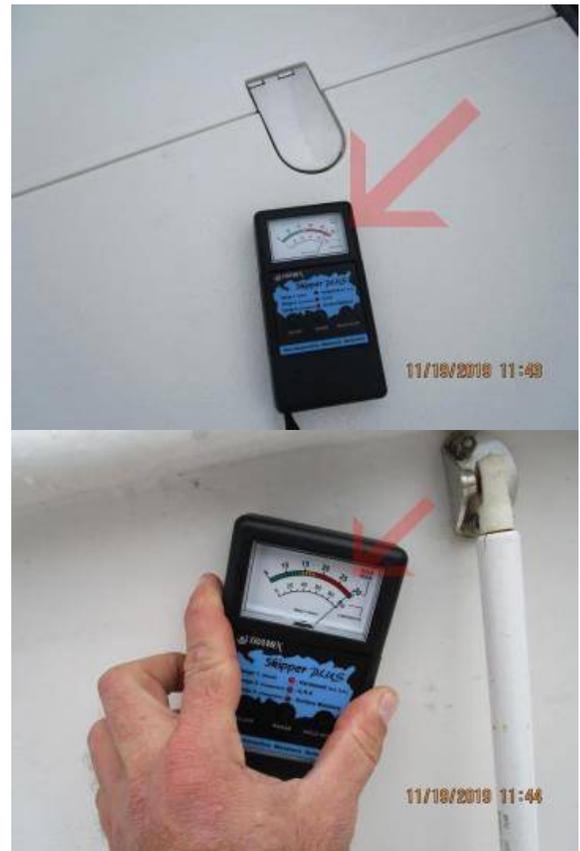
Moisture/Delamination: All moisture meter readings on sole were relatively dry with normal comparative moisture meter readings. Exception, aft upper deck hatch shows readings of elevated moisture.

| Findings: | Recommendations: |
|---|--|
| Aft upper deck hatch shows readings of elevated moisture. | Have a qualified FRP technician further investigate, evaluate and repair as necessary. |

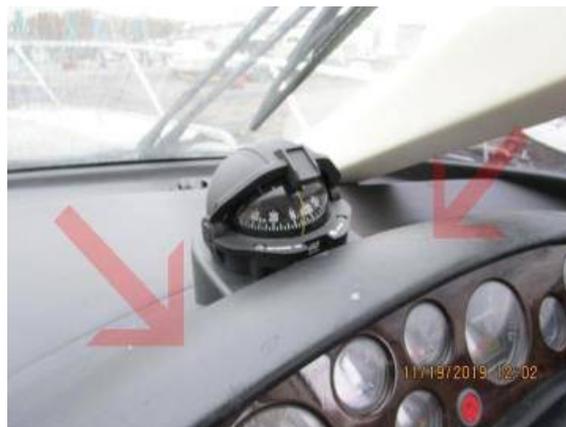
Helm station: Lower and Flybridge helm stations. Lower helm upholstery has deteriorated and become sticky.

| Findings: | Recommendations: |
|---|--|
| Lower helm upholstery has deteriorated and become sticky. | Have a qualified technician further investigate, evaluate and repair as necessary. |

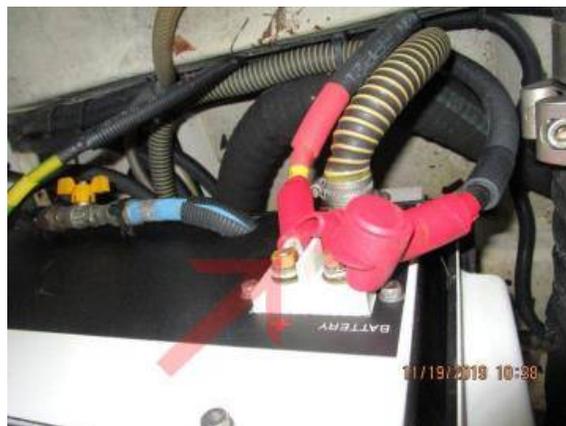
Findings: Sighted some DC terminal connections on the backside of the generator that are not protected which could lead to a sparking hazard. The only exception is circuits that have over current protection at the source of power.

Recommendations: **RECOMMENDATION:** ABYC E-11.5 recommends as follows: *"Continuously energized parts, such as positive battery terminals and both ends of all wire connected thereto, shall be physically protected with boots, or other form of protection, that cover all energized surfaces to prevent accidental short circuits."*

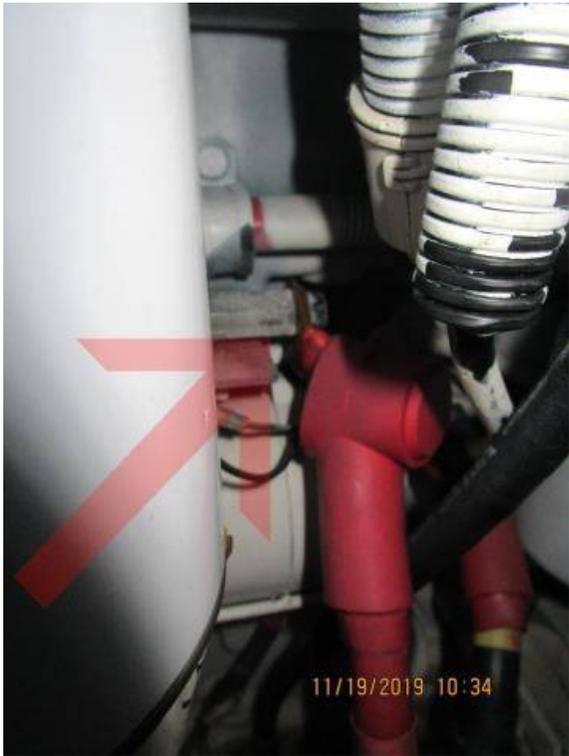
Ignition protection: Alternator and Starter appear to be OEM and ignition protected.
Port starter: Sighted DC terminal connections that are not protected which could lead to a sparking hazard. The only exception is circuits that have over current protection at the source of power.

| Findings: | Recommendations: |
|--|---|
| Port starter: Sighted DC terminal connections that are not protected which could lead to a sparking hazard. The only exception is circuits that have over current protection at the source of power. | RECOMMENDATION: ABYC E-11.5 recommends as follows: " <i>Continuously energized parts, such as positive battery terminals and both ends of all wire connected thereto, shall be physically protected with boots, or other form of protection, that cover all energized surfaces to prevent accidental short circuits.</i> " |

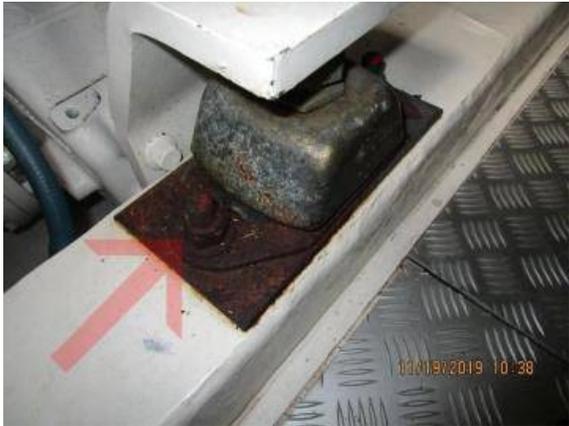
Engine mounts and beds: Engine mounts appear to be well secured to the support stringers. **Port rear inner mount shows excessive corrosion.** NOTE: See Hull Interior section for condition of stringers themselves.

| Findings: | Recommendations: |
|--|---|
| Port rear inner motor mount shows excessive corrosion. | Have a qualified marine technician further investigate corrosion sighted on motor mount, evaluate and repair as necessary. |
