REPORT OF MARINE SURVEY

"XXXXXXXXXXXX"

2003/Cranchi/Endurance 33

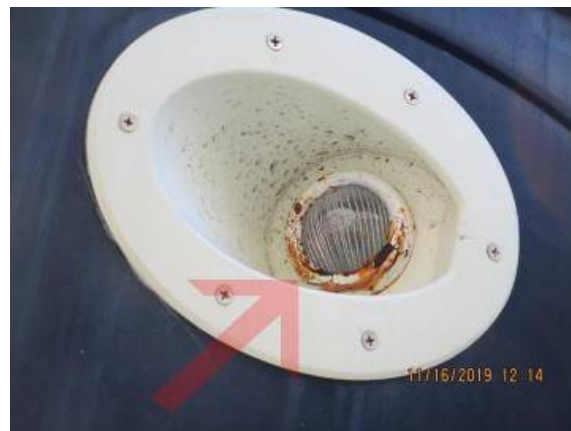
Docking lights: Docking lights installed on both forward sides of hull. Both lights power up properly when tested. Port side light shows signs of severe corrosion.

Findings:	Recommendations:
Port side docking light shows signs of severe corrosion.	Further investigate and repair with like kind parts and general marine practices.

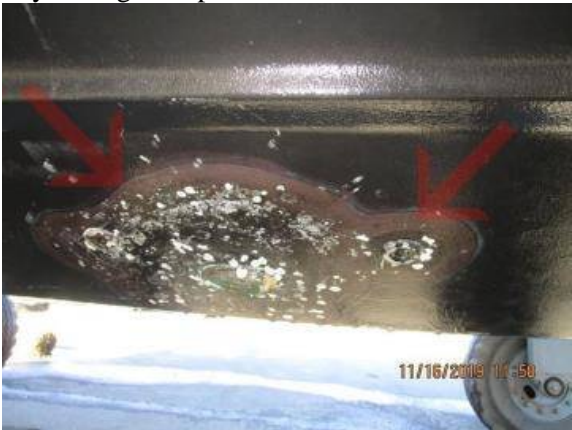
were relatively dry with normal comparative moisture meter readings. No delamination discovered when randomly testing with percussion hammer. All strainers/screens are well secured to hull bottom. Clear of debris & marine growth. **Haloing** sighted around the port side raw water engine strainer.

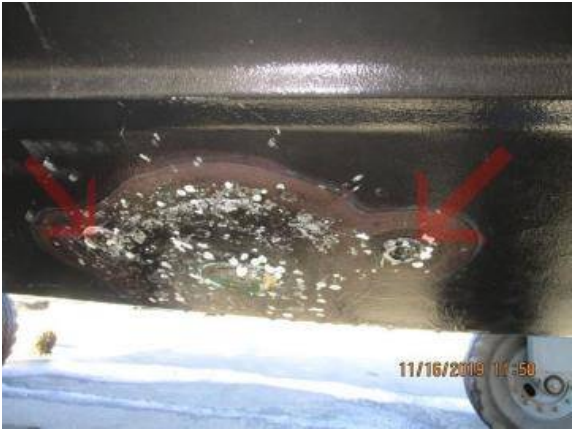
Mushroom type bronze fittings for all below water line sea cock locations. Well secured to hull bottom. **Haloing** sighted around the two through hulls in the area of the port side engine strainer.

Findings:	Recommendations:
Haloing sighted around the port side raw water engine strainer. Haloing sighted around the port side raw water engine strainer as well as the two other through hulls in the area.	Haloing is an indicator of stray current leaking from the vessel. A qualified marine technician should further investigate, evaluate and repair as necessary.

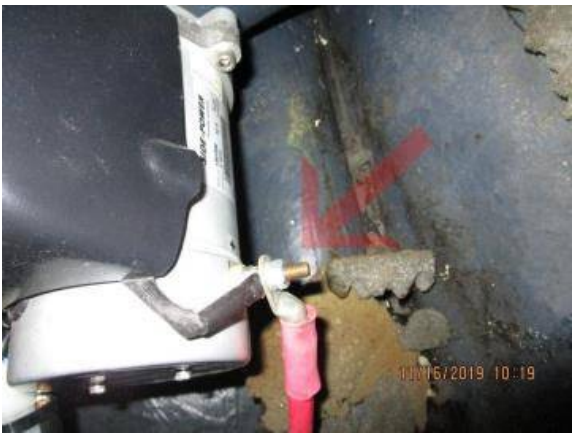
Side Power thruster system, Prop drive fitting is securely mounted inside the thruster tube which is well fared into the hull and securely fastened. No cracks sighted where thruster tube is fit into hull. Thruster fit with 5 blades on each side. All blades intact. Powers up and is functional. Positive terminal(s) not covered as required. RECOMMENDATION: Code of Federal Regulations - CFR33.183.420 mandates that positive terminals be protected against accidental shorting by the use of insulation barriers or sleeves or with battery case cover. Recommend compliance with Code of Federal Regulations.

Findings:	Recommendations:
Positive terminal(s) not covered as required.	Code of Federal Regulations - CFR33.183.420 mandates that positive terminals be protected against accidental shorting by the use of insulation barriers or sleeves or with battery case cover. Recommend compliance with Code of Federal Regulations.

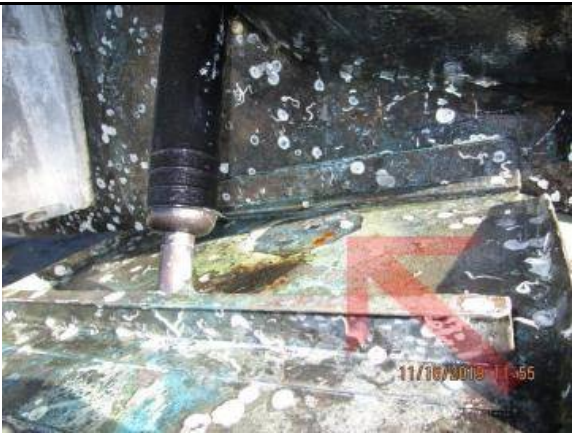
Trim tabs: Missing.

Replacement required?: Trim Tabs. Transom Anode.
Anode notes: Monitor all anodes frequently on hull and underwater equipment and replace when they are no more than 50% wasted. Anodes are normal replacement items designed to help protect the running gear from electrolysis. Keep spares aboard vessel.

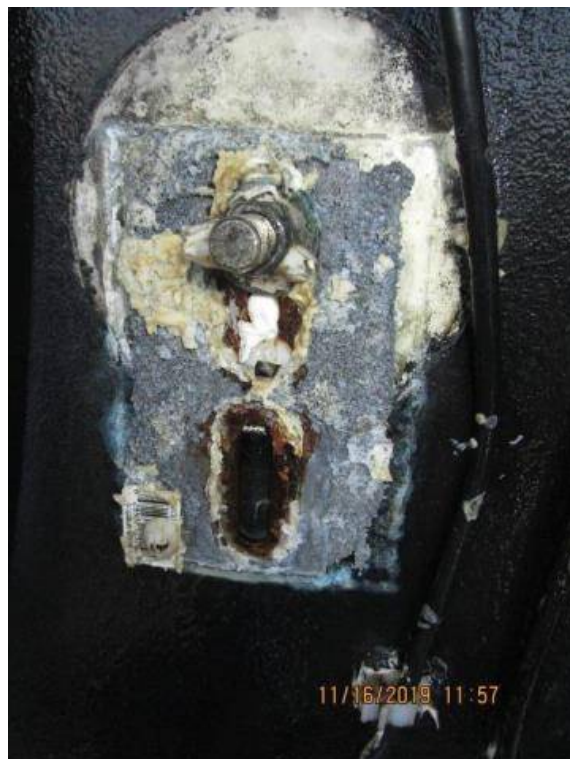
Hull mounted: Two ground/anodes securely mounted on hull bottom. No deterioration sighted. **Transom anode** securely mounted. More than 50% of deterioration sighted.

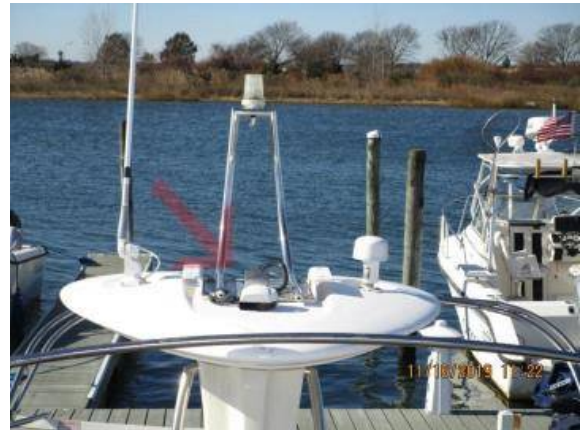
Helm station:	Main Helm station, with tilt wheel steering.
Compass(es):	Mounted at main helm: 6" Ritchie Powerdamp.
VHF radio(s):	Mounted at main helm: Raymarine Ray240. Serial number was not sighted. Unit is built in.
Depth sounder(s):	Mounted at main helm: Raymarine. Functional. Serial number was not sighted. Unit is built in.
Speed instrument(s):	Mounted at main helm: Raymarine. Functional. Serial number was not sighted. Unit is built in.
Multi-function instrument(s):	Mounted at main helm: Simrad G09 XSE S/N: 118756603.
Radar:	Mounted at main helm: Furuno The Radar did not power up and array is missing.

Findings:	Recommendations:
The Radar did not power up and array is missing.	Repair or replace as necessary.

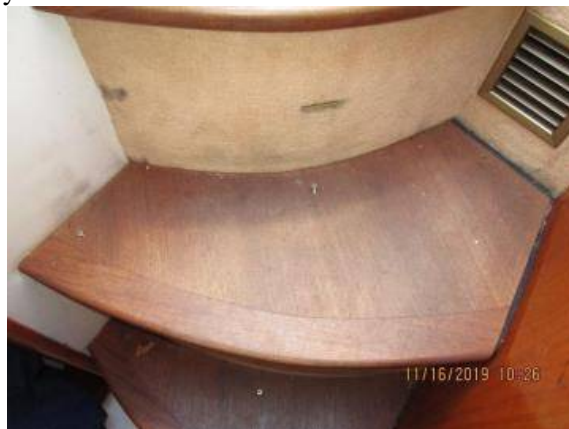
Style: Contemporary, combined with galley and dinette area.
Cabin steps: Teak cabin entrance steps. **All steps are loose.**

Findings:	Recommendations:
Cabin steps are all loose.	Secure steps as to prevent injury.

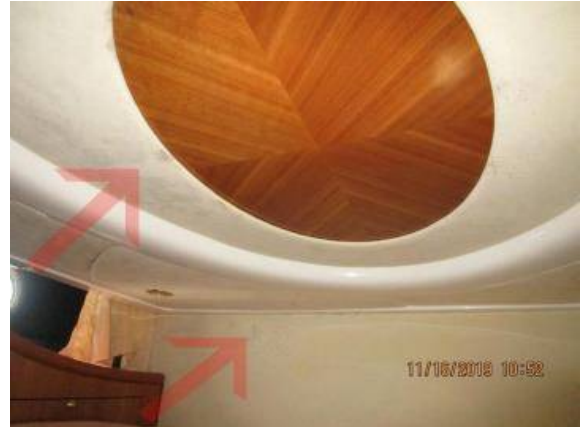
Berths: Single berth aft cabin sleeps two.
Damage sighted: Mold sighted.

Recommendations: Further investigate source of mold and clean aft cabin.

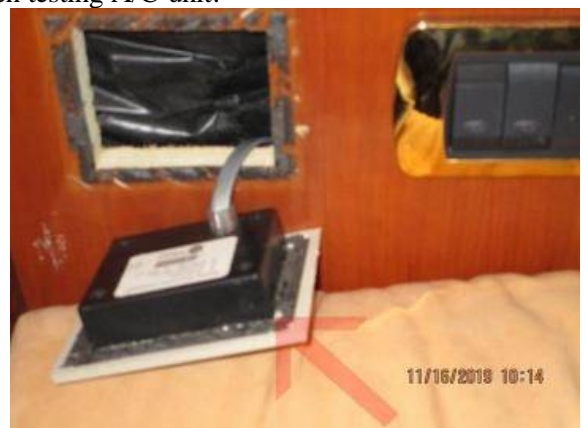
Manufacturer & Type: Cruisair, 120 volt - reverse cycle.
Locations / BTU Capacity: Main cabin, 12,000 BTU.
Temp Controls: Cruisair SMX II digital temperature controls.
Filter(s) Condition: Filters appeared clean. *Recommend that A/C filter(s) be checked and cleaned frequently to allow the A/C unit to operate at maximum efficiency.*
Condensate drain: Drains into sump tank.
A/C Raw water: Bronze sea cock for A/C Raw water intake. Fully functional and hose is double clamped with sea strainer.
Hoses & connections: Hoses appear to be adequate size and serviceable for application. No cracks or hose damage sighted. Hoses are clamped and secure on all fittings sighted.
Raw water cooling pump: 120 Volt pump functioned well when testing A/C unit.
Damage sighted: Control panel not secured.

Recommendations: Secure control panel.

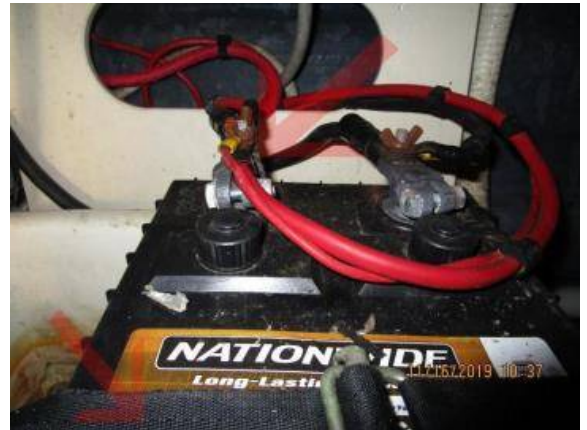
Port battery set has a total of one 12 Volt sized sized that are type 4D970 lead acid batteries that are located in the engine compartment which provide service to house and engine start. **Battery not fully secured. RECOMMENDATION:** Code of Federal Regulations CFR33.183.420 mandates that batteries be well secured from movement of no more than 1" in any direction with a pull force of 90 lbs or 2 times the battery weight. Recommend compliance with Federal Law. Positive terminal(s) not covered as required. **RECOMMENDATION:** Code of Federal Regulations - CFR33.183.420 mandates that positive terminals be protected against accidental shorting by the use of insulation barriers or sleeves or with battery case cover. Recommend compliance with Code of Federal Regulations.

Findings:	Recommendations:
Port and starboard batteries not fully secured. RECOMMENDATION: Code of Federal Regulations CFR33.183.420 mandates that batteries be well secured from movement of no more than 1" in any direction with a pull force of 90 lbs or 2 times the battery weight. Recommend compliance with Federal Law. Port and starboard battery positive terminal(s) not covered as required. RECOMMENDATION: Code of Federal Regulations - CFR33.183.420 mandates that positive terminals be protected against accidental shorting by the use of insulation barriers or sleeves or with battery case cover. Recommend compliance with Code of Federal Regulations. Some DC breaker labels unreadable.	RECOMMENDATION: Code of Federal Regulations CFR33.183.420 mandates that batteries be well secured from movement of no more than 1" in any direction with a pull force of 90 lbs or 2 times the battery weight. Recommend compliance with Federal Law. RECOMMENDATION: Code of Federal Regulations - CFR33.183.420 mandates that positive terminals be protected against accidental shorting by the use of insulation barriers or sleeves or with battery case cover. Recommend compliance with Code of Federal Regulations. Label all DC breakers to comply with ABYC E-11.5 recommendations.

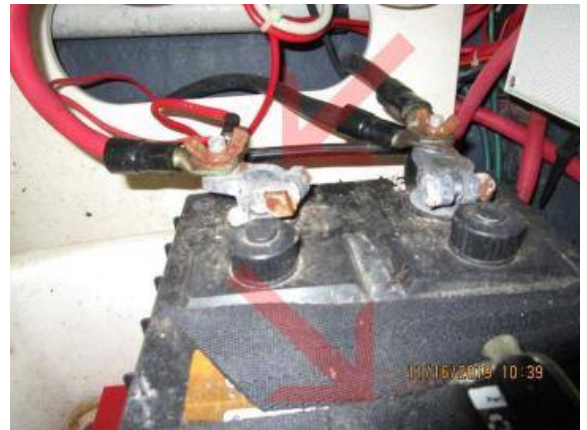
Starboard battery set has a total of one 12 Volt sized sized that are type 4D970 lead acid batteries that are located in the engine compartment which provide service to house and engine start. **Battery not fully secured. RECOMMENDATION:** Code of Federal Regulations CFR33.183.420 mandates that batteries be well secured from movement of no more than 1" in any direction with a pull force of 90 lbs or 2 times the battery weight. Recommend compliance with Federal Law. Positive terminal(s) not covered as required. **RECOMMENDATION:** Code of Federal Regulations - CFR33.183.420 mandates that positive terminals be protected

against accidental shorting by the use of insulation barriers or sleeves or with battery case cover. Recommend compliance with Code of Federal Regulations.

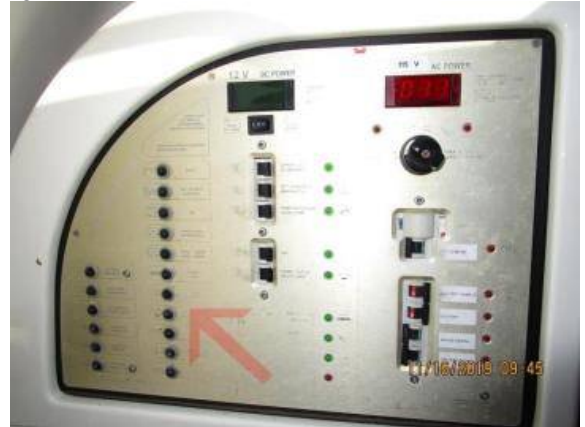
Located in main salon combined with A.C. power panel. Some DC breaker labels unreadable.

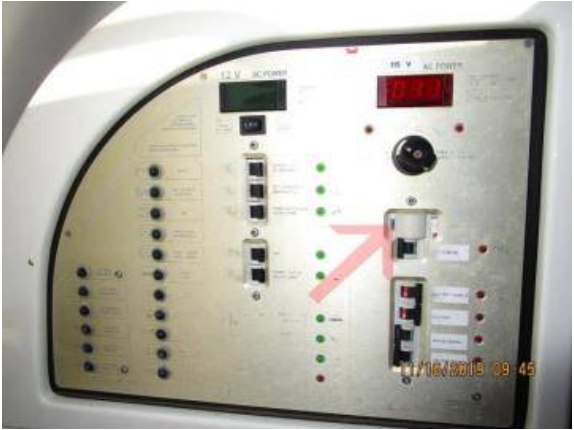
An ELCI (Electrical Leakage Circuit Interrupter) is installed in the main shore power conductor between the boats shore power connection and the AC panel and was sighted at the main panel. The ELCI is for whole boat protection for leaks to ground that would go outside of the boat hull for in water swimmer protection and measures the imbalance between the hot and neutral and will trip at 30 milliamps. *NOTE: If the ELCI trips, the owner should shut down all AC circuits, reset the ELCI, and then power up circuits one at a time until the ELCI trips again. The AC device that tripped the ELCI needs to be serviced.* Unit not functional, generator was used to test AC power bank for survey.

Findings:	Recommendations:
ELCI unit not functional.	A qualified marine technician should further investigate, evaluate and repair as necessary.
No GFCI protection sighted for 110V outlets in/near wet locations (galley, head).	Provide GFCI protection as currently recommended by ABYC E-11 and NFPA 302. (Install a GFCI equipped breaker in each wet location or as first outlet from power

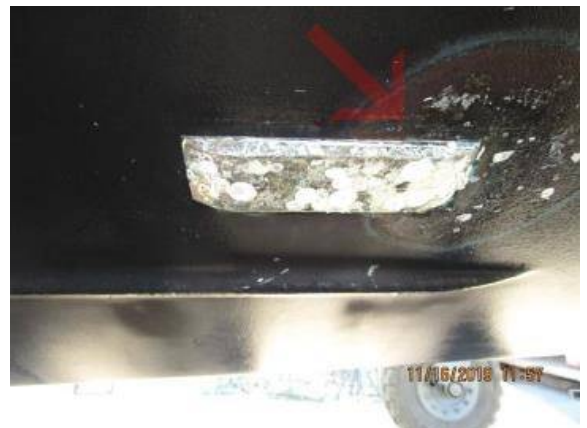
Main bonding conductor:	Twin engines are properly connected to each other by a common conductor circuit. The remaining ground/bonding system is well established where sighted; Electrical system, Seacocks, Shaft logs, Rudders, Sea Strainers, Pumps, Fuel system/tanks, Hull Zincs were all bonded. The bonding system is using individual green insulated wire or copper strips.
Generator set(s) :	Generator engine ground bus.
Through-hull(s) connected:	Connected.
Sea strainer(s) connected:	Connected.
Trim tabs connected:	Connected.
Grounding plate(s):	External-well secured to hull and ground wires well secured. Haloing also sighted around the port side grounding plate.

Findings:	Recommendations:
Haloing also sighted around the port side grounding plate.	Haloing is an indicator of stray current leaking from the vessel. A qualified marine technician should further

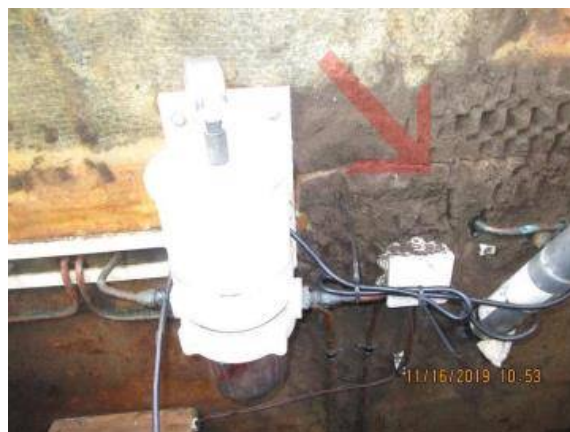
Insulation:	Sighted in very poor condition, replacement recommended.

Findings:	Recommendations:
Engine compartment insulation sighted in very poor condition.	Engine compartment insulation replacement recommended.

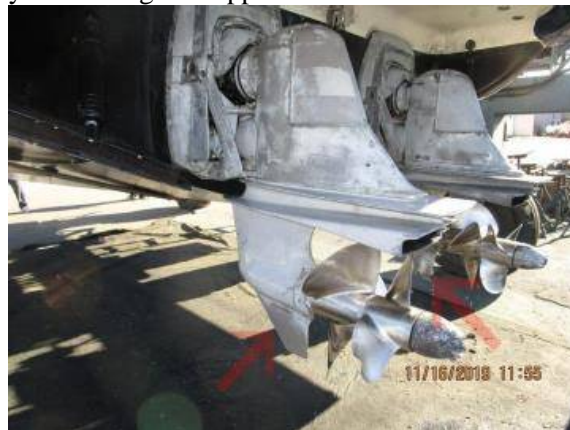
Skeg condition:	Corrosion deterioration damage sighted on lower skeg(s).

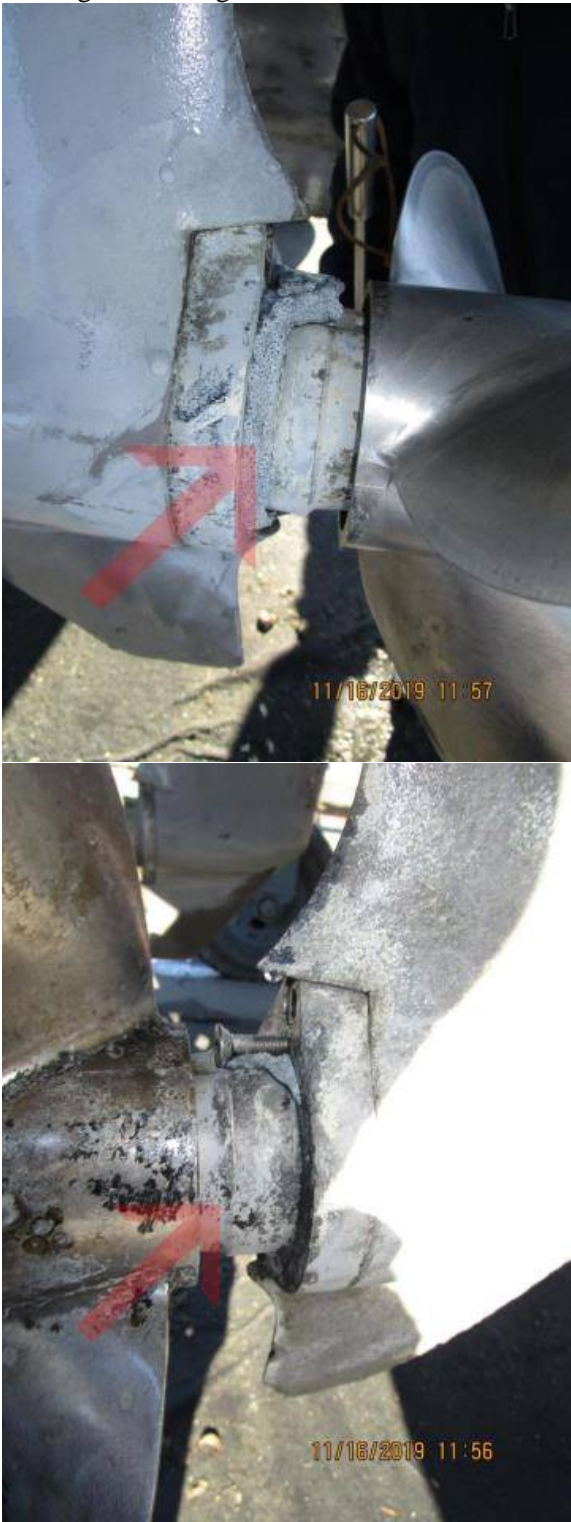
Port and starboard collar anodes show excessive deterioration. RECOMMENDATION: Replace collar anodes. Monitor all anodes frequently and replace as necessary. Anodes are normal replacement items designed to protect the running gear from electrolysis. Keep spares aboard vessel.

Port and starboard collar anodes show excessive deterioration.

Replace collar anodes.

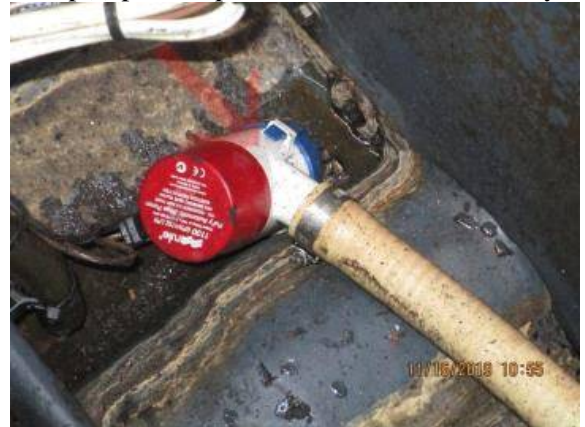
Two electric fully automatic pumps. Located at: Engine compartment bilge Pumps sighted are: Rule 12 volt, 500 GPH, 1100 GPH, Pump(s) power up when switched on manually. Fwd bilge pump located at engine space is adrift and Not secured to hull bottom. RECOMMENDATION: ABYC H-22 recommends that all bilge pumps be securely fastened to the hull bottom in order to resist pump movement under normal marine service.

Recommend compliance.
