**REPORT OF MARINE SURVEY**

**"XXXXXXXXXXXXXXXXXXXX"**

**2014/Tiara/4800 Convertible**

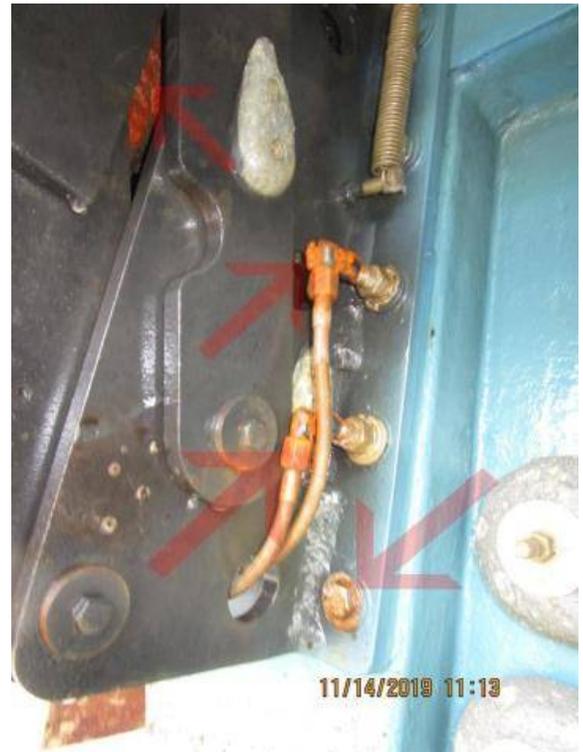
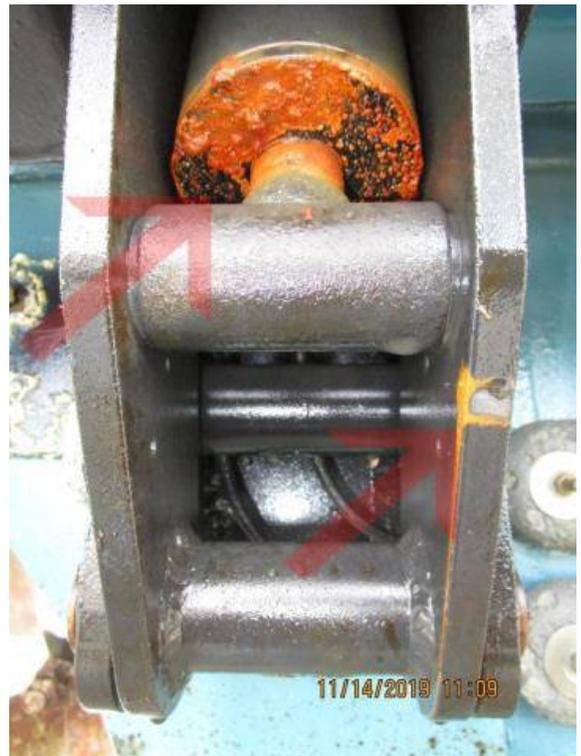
<b>Transom type:</b>	Conventional flat transom.
<b>Moisture/Delamination:</b>	All moisture meter readings on transom and surrounding thru-hull fittings were relatively dry with normal comparative moisture meter readings. No delamination discovered when randomly testing with percussion hammer.
<b>Transom cosmetics:</b>	Very good transom surface condition.
<b>Swim Platform/Step:</b>	Attached fiberglass swim platform is well secured to transom.
<b>Swim/Boarding ladder:</b>	The boarding ladder is stainless steel drop down that is mounted in swim platform pocket. The ladder rungs are stainless steel. The ladder is well secured and functional.
<b>Davit system:</b>	Freedom Lift. Functional Freedom lift davit system shows signs of incorrect bonding showing excessive corrosion.

Findings:	Recommendations:
Freedom lift davit system shows signs of incorrect bonding showing excessive corrosion. Trim tab anodes missing.	Have a qualified marine electrical technician further investigate davit corrosion and repair as necessary. Replace trim tab anodes.

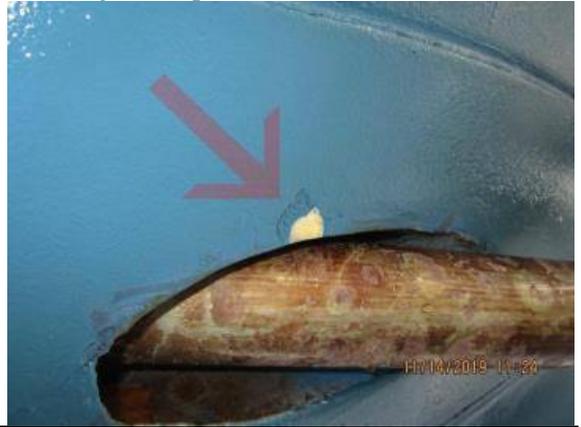
**Damage sighted:** Minor FRP damage on port side where the prop shaft exits the vessel.

Findings:	Recommendations:
Minor FRP damage on port side where the prop shaft exits the vessel.	Have a qualified marine fiberglass technician further investigate the FRP damage and repair as necessary.

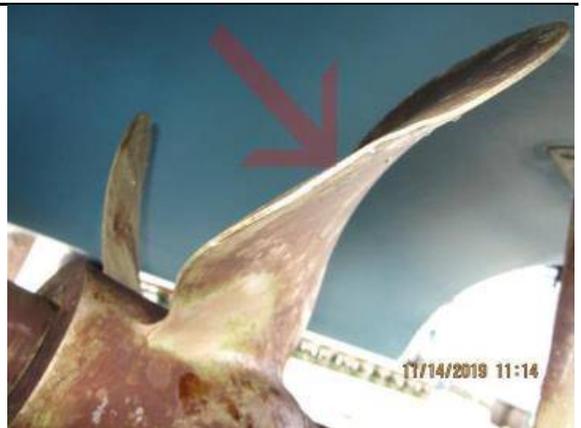
**Prop(s) description:** Bronze 1015 LH/RH 30" x 45 4BL. Minor damage on 1 blade of port side prop.

**Damage sighted:** Minor damage on 1 blade of port side prop.

<b>Findings:</b> Prop nuts installed backwards.	<b>Recommendations:</b> Recondition port propeller.
--	--

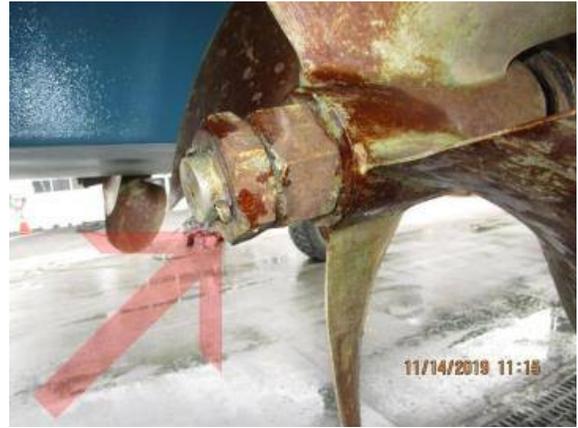
**Other notes:** Prop nuts are installed backwards.

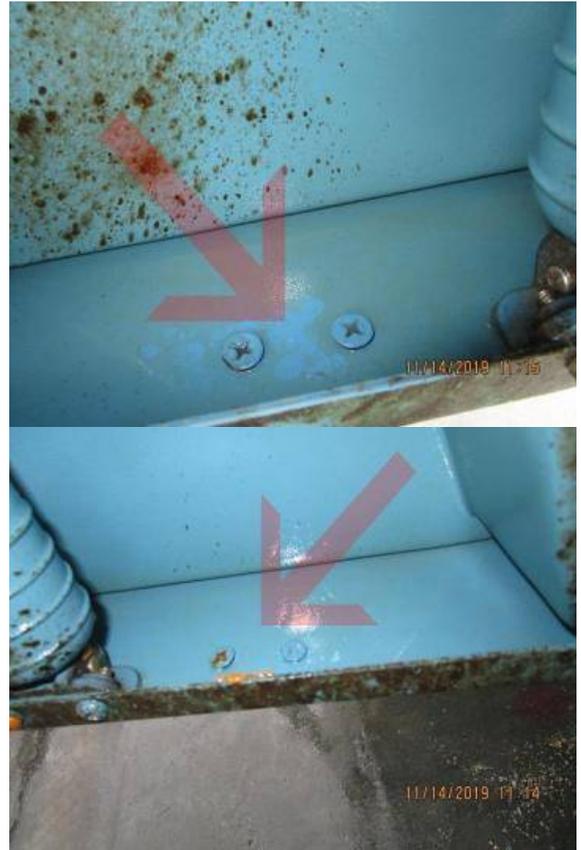
**Trim tabs:** Missing.

**Replacement required?:** Trim Tabs.

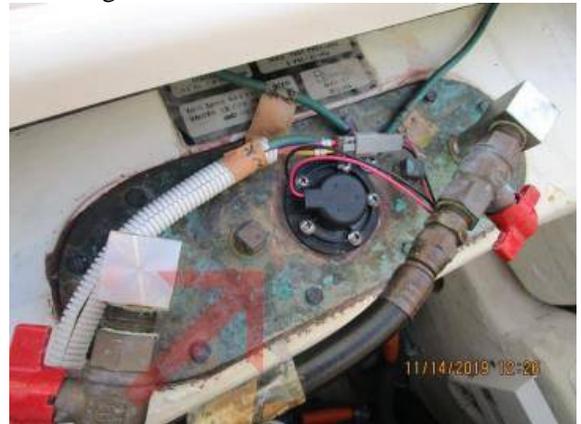
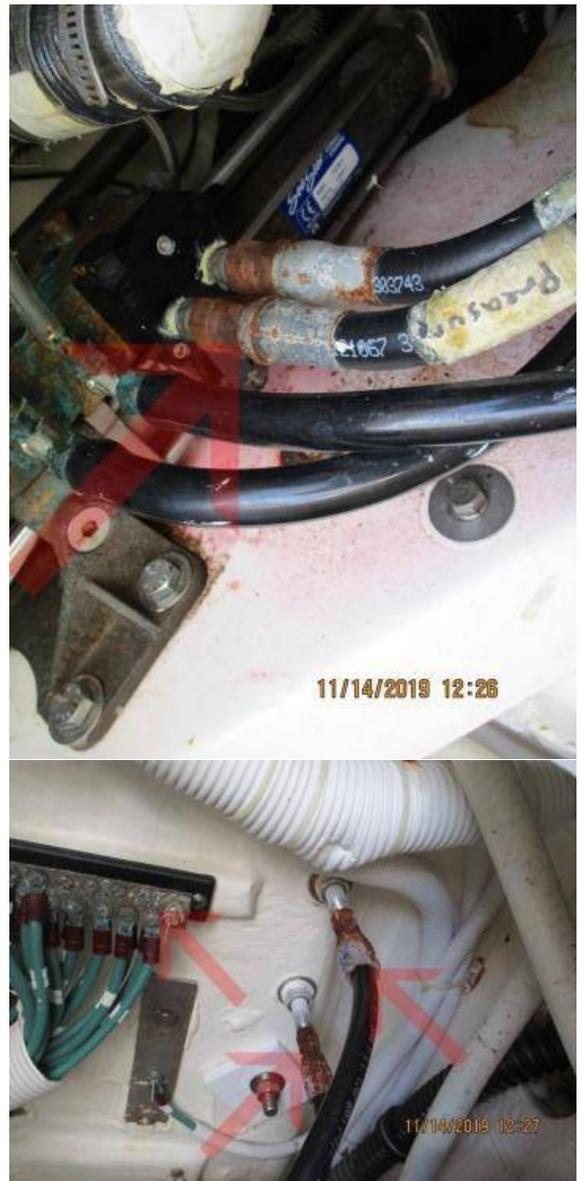
**Bilge(s):** Clean and dry for areas open to inspection with exception of the **excessive corrosion to fittings and components sighted in the aft bilge (see Findings)**. *NOTE: Whenever you visit your boat, it's good practice to check the bilge area(s) for higher than normal levels of water and proper functionality of the bilge pump(s) or anything else that could be causing trouble.*

<b>Findings:</b>	<b>Recommendations:</b>
Excessive corrosion to fittings and components sighted in the aft bilge.	Have a qualified marine technician further investigate the excessive corrosion and repair as necessary.

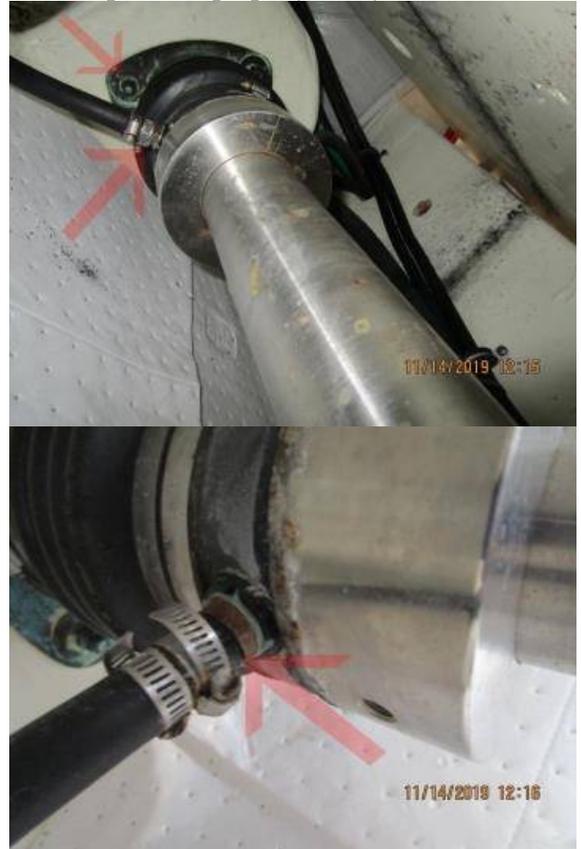
**Stuffing box(es):** Starboard: Dripless shaft seal system that is raw water cooled. Boot, raw water hose and collar is secure and appears functional.  
Port: Dripless shaft seal system that is raw water cooled. Boot, raw water hose and collar is secure and appears functional.  
Excessive corrosion was sighted as well as water around the port side unit indicated the unit may be leaking.

<b>Findings:</b>	<b>Recommendations:</b>
Excessive corrosion was sighted as well as water around the port side shaft seal unit, indicating the unit may be leaking.	Have a qualified marine technician further investigate the corrosion and potential leaks on the port side shaft seal unit and repair as necessary.

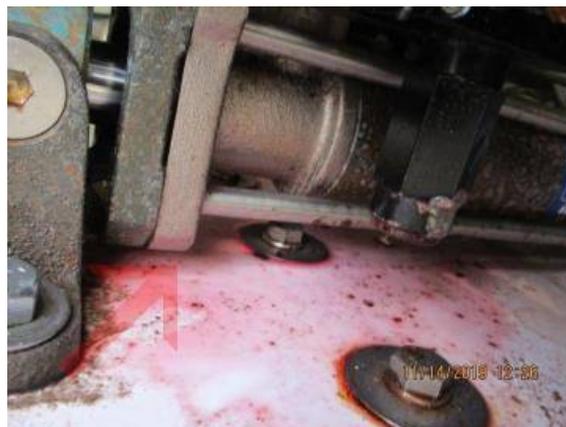
**Mounting(s):** Cylinder & ram actuator well secured. Moderate leaking sighted at ram acuator.

**Steering tie bar:** Well mounted with rudder steering arms connected by a stainless steel lateral bar.  
**Lines and fittings:** No leaks sighted.  
**Packing glands:** Appear well sealed- no leaks sighted. *NOTE: Rudder packing glands should always be totally dry. Check frequently and adjust if necessary.*  
**Damage sighted:** Moderate leaking sighted at ram acuator.  
**Recommendations:** Have a qualified marine technician further investigate the leaking ram unit and repair as necessary.
