REPORT OF MARINE SURVEY

"XXXXXXXXXX"

2006 Viking Sport Cruiser SC57

**Barton P. Cerra
on
November 19, 2019**

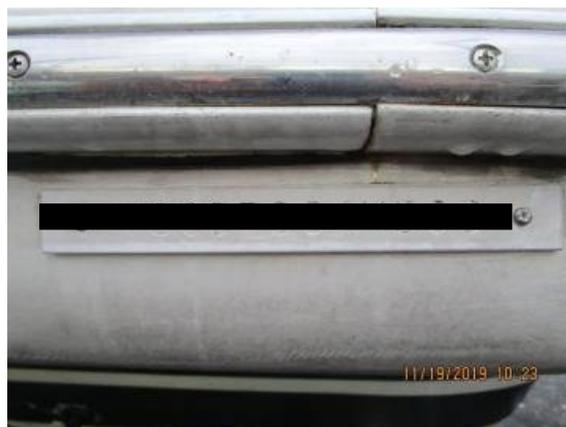
Hull ID number (HIN): -XXXXXXXXXX A true digital photograph of the hull ID number of the referenced vessel is shown here and was found located on the transom..

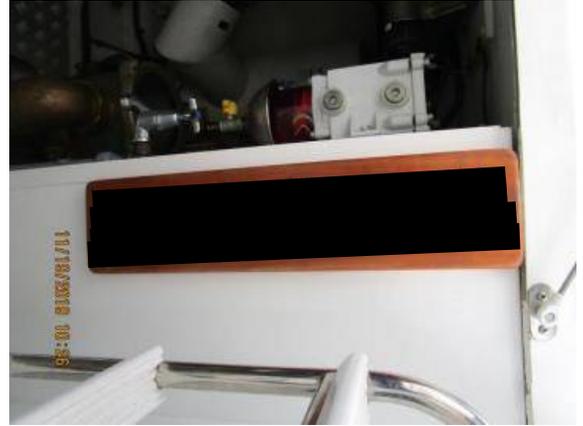
Official Documentation No: XXXXXXXXXXXX.

Documented name: XXXXXXXXXXXX.
Documented hailing port: XXXXXXXXXXXX.
Documented use: Recreational.
Documented Specs: Length: 57.5, Breadth: 16.1, Depth: 7.8, Gross Tons: 48, Net Tons: 38. *Note: The measurements of breadth and depth are incorrect on documentation, correction is recommended.*
Documented restrictions: None.
Documented owner: XXXXXXXXXXXX.
Documentation current: XXXXXXXXXXXX.
