REPORT OF MARINE SURVEY

"XXXXXXXXXXXX"

2003/Cranchi/Endurance 33

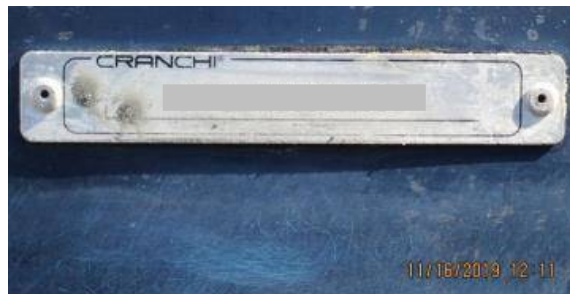
Vessel Yr/Make/Model: 2006/Cranchi/33Endurance.
Vessel name: XXXXXXXXXXXXX.
Hailing port: XXXXXXXXXXXXX.
Hull ID number (HIN): -XXXXXXXXXXXXX A true digital photograph of the hull ID number of the referenced vessel is shown here and was found located on the transom.
