**REPORT OF MARINE SURVEY**

**"XXXXXXXXXXXXXXXXXXXX"**

**2014/Tiara/4800 Convertible**

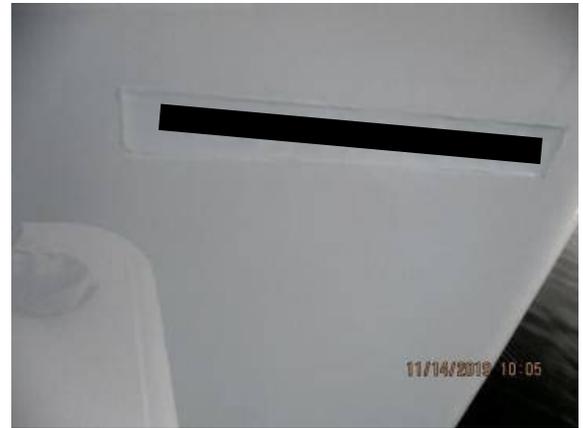
**Hull ID number (HIN):** -xxxxxxxxxxxxxxxxxx, A true digital photograph of the hull ID number of the referenced vessel is shown here and was found.
